Manhole Inspection Summary

Manhole # S53AA_014MH

Inspection ☐ Is Incomplete Rating: **3) Fair**

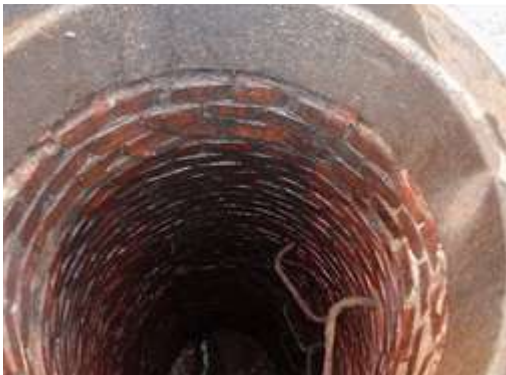
Defect 2

☒ **Leaks**

Frame Leaks

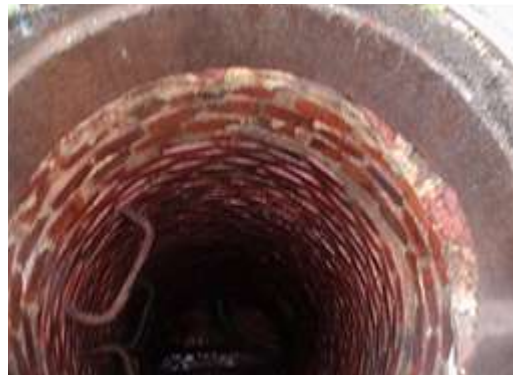
Defect 1

Adjustment Joint

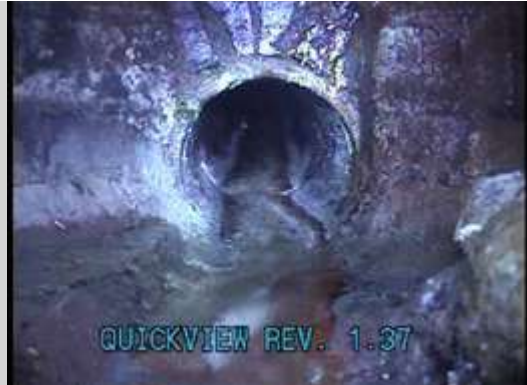
12 O'Clock Outflow

8 in. Circular Gravity Sewer
Pipe Out @ 12 O'Clock

Pipe Height: **8.4** (in.) Rod and Bar (Angled)
Pipe Material: **Clay** ☐ Pipe Lined
Invert Depth: **17.70** (ft.) Flow Characteristics: **Fast**
Deposits: ☒ None ☐ Mud ☐ Sludge ☐ Debris ☐ Grease
Silt Depth: (in.) Deposits Extent:
Infiltration: **None** Pipe Seal Cond: **Sound**

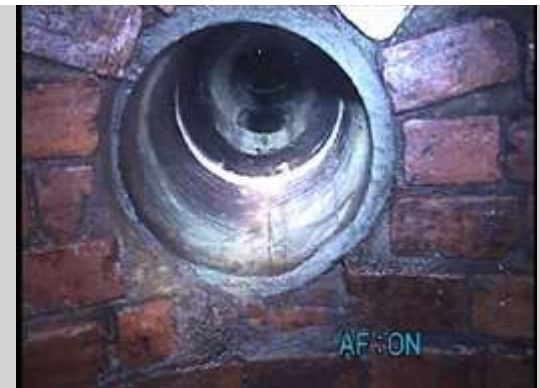
3 O'Clock Inflow

8 in. Circular Gravity Sewer
Pipe In @ 3 O'Clock

Pipe Height: **8.4** (in.) Rod and Bar (Angled)
Pipe Material: **Clay** ☐ Pipe Lined
Invert Depth: **8.35** (ft.) Flow Characteristics: **Fast**
Deposits: ☒ None ☐ Mud ☐ Sludge ☐ Debris ☐ Grease
Silt Depth: (in.) Deposits Extent:
Infiltration: **None** Pipe Seal Cond: **Sound**

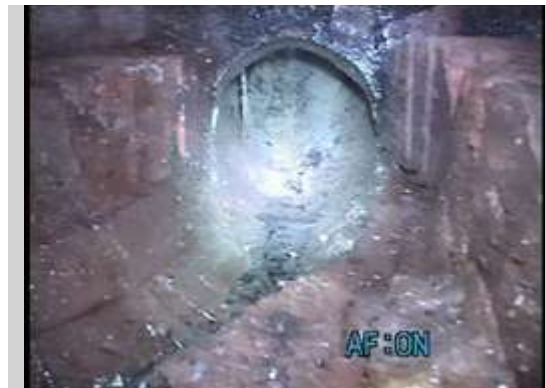
Drop In @ 3 O'Clock

Drop: **Inside** Rod and Bar
Angled: **Yes** Reading: **16.30** (ft.)
Inv Depth: **17.30** (ft.)
Drop Condition: **Open**

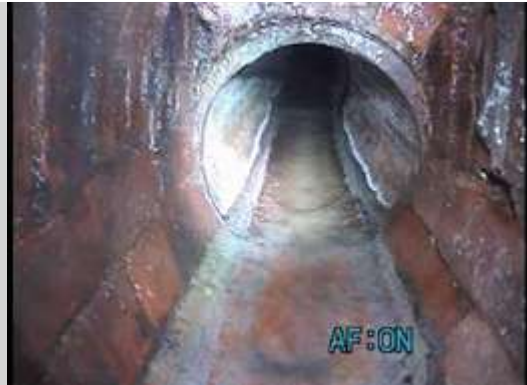
6 O'Clock Inflow

Pipe In @ 6 O'Clock

Infiltration: **None** Pipe Seal Cond: **Sound**

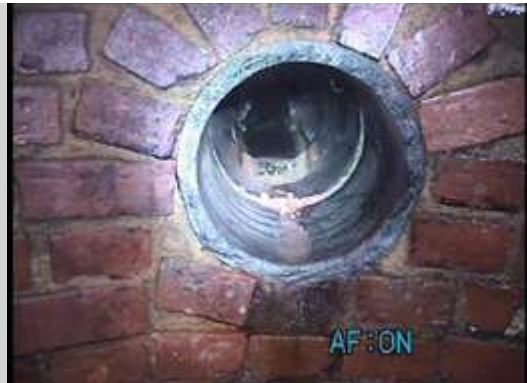
9 O'Clock Inflow

Pipe In @ 9 O'Clock

Infiltration: **None** Pipe Seal Cond: **Sound**

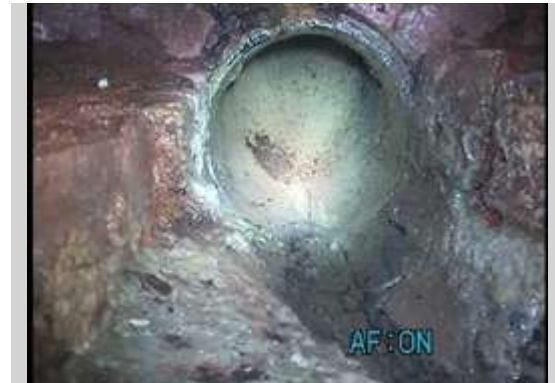
Drop In @ 9 O'Clock

Drop: **Inside** **Rod and Bar**
Angled: **Yes** Reading: **16.20** (ft.)
Inv Depth: **17.20** (ft.)
Drop Condition: **Open**
